Stucco Check Inspections, LLC

## Invasive Stucco Inspection

# SAMPLE REPORT

Sample  
Houston, TX

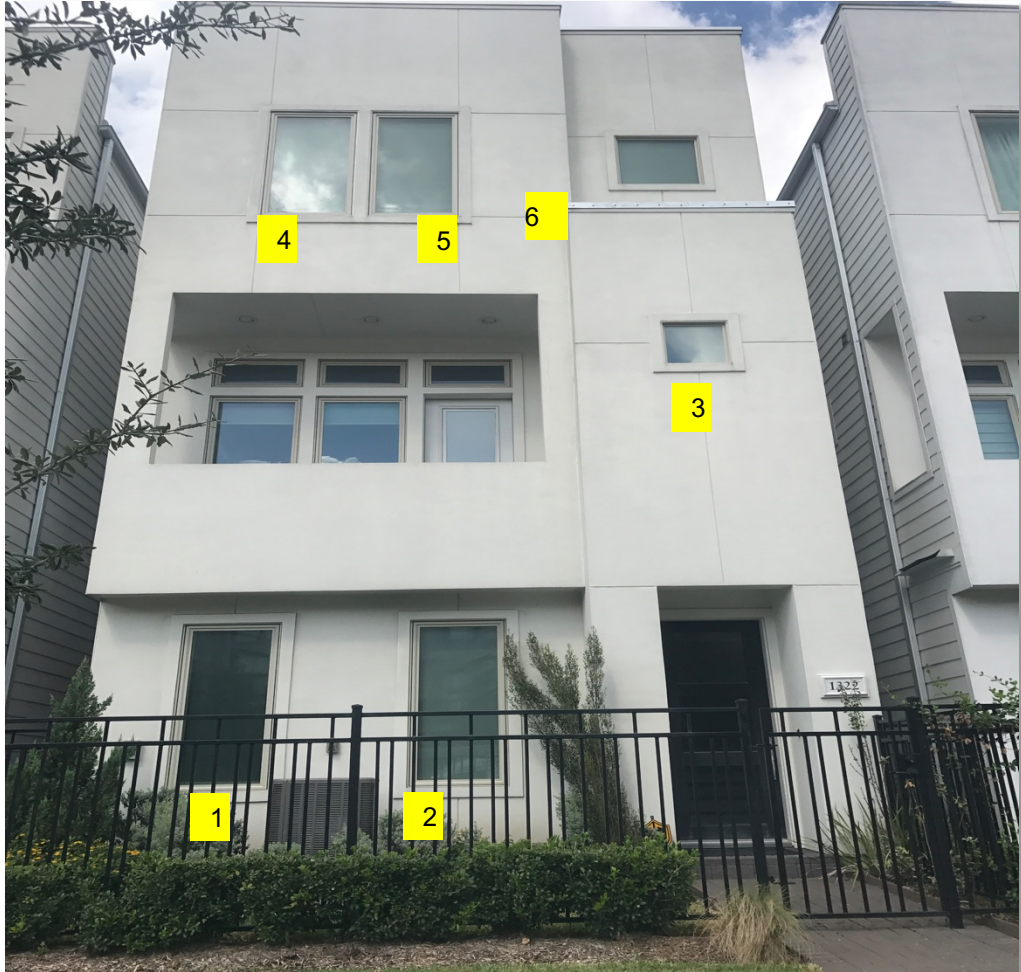
Location	Moisture Reading	Substrate Condition	Comments
1	24%	Firm	Probes below front elevation windows. Sealants are noted to be deficient throughout all windows. It is suggested to Assess all windows, doors, utility breeches, and penetrations and seal as needed using a low modulus sonolastic sealant. Sealants are suggested to be replaced every 2-3 years.  Mid-to-Elevated moisture but firm substrate noted at time of inspection.
2	29%	Firm	
3	40%	Firm	
4	33%	Firm	
5	31%	Firm	
6	15%	Firm	Probe below corner of flat roof. A metal cap flashing is noted at this location. No kick out flashing noted. Acceptable moisture and firm substrate noted at time of inspection.

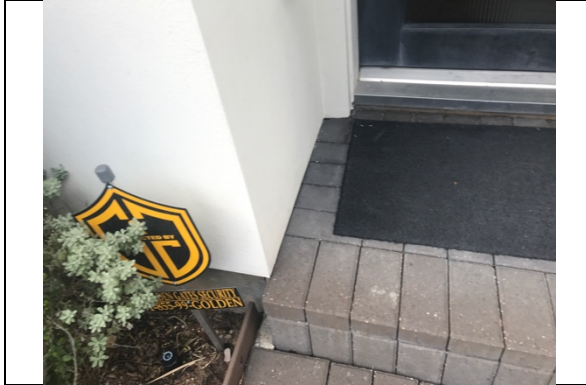
Stucco walls noted to have a proper clearance from the floor. The stucco terminates with a weep screed. This is favorable. The entry pavers, however, are brought up to the base of the stucco walls.

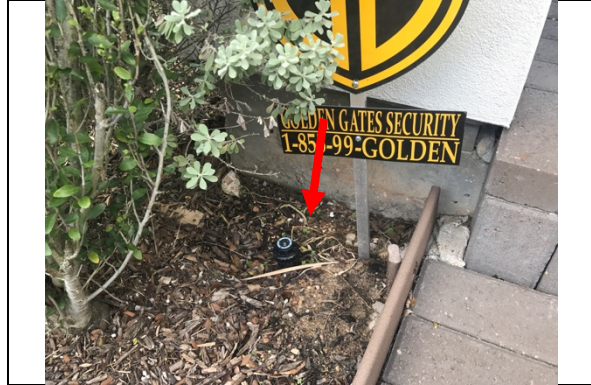
Sprinkler heads are in close proximity to the stucco walls. It is recommended to re-direct all sprinkler heads away from stucco walls

- Sprinklers suggested to be re-directed away from stucco walls to avoid backsplash and excess moisture.
- Substrate Damages- All areas noted to have not firm substrate (Semi-soft/Soft) Suggested to be opened up to verify damage, and repaired accordingly.

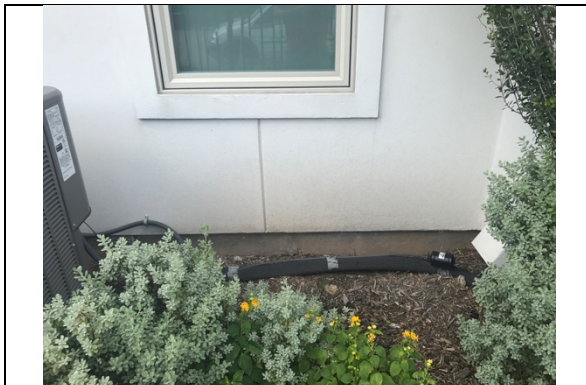
Light mildew/run-off staining noted along base of stucco wall.

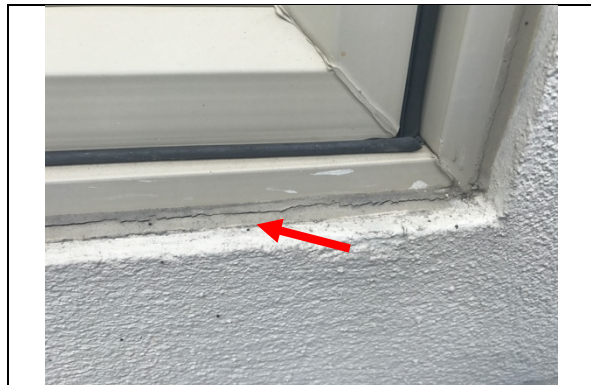
Sealants at all stucco- window junctions have reached their life expectancy. Sealants are starting to fail adhesively and cohesively. It is suggested to have all sealants replaced every 2-3 years

- All windows, doors, and penetrations through the system should be professionally sealed using a high quality, professional sealant, suggested by manufacturer of your system and properly tooled into joints to help prevent moisture intrusion and sealant separation. Sealants are suggested to be replaced every 2-3years.

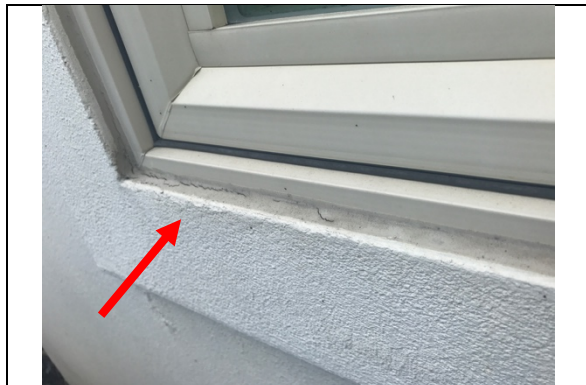
Sealants at all stucco- window junctions have reached their life expectancy. Sealants are starting to fail adhesively and cohesively. It is suggested to have all sealants replaced every 2-3 years

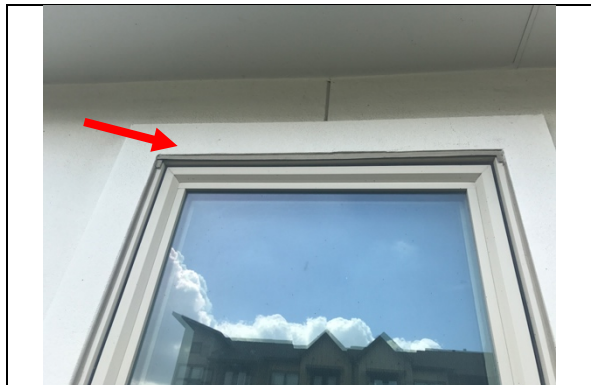
Window head flashings noted above window frames.

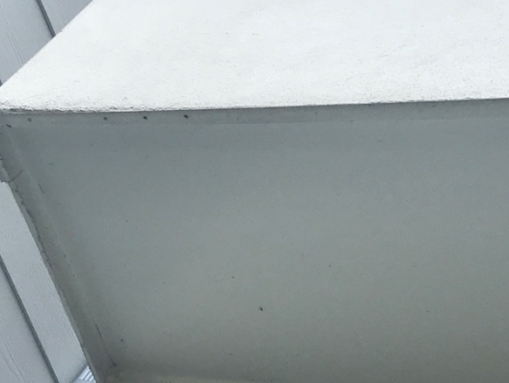
Stucco overhangs noted to terminate with a perforated casing. Many holes along the casing, however, have been covered with paint/ stucco materials. Suggested to re-open

- Stucco Overhangs- Stucco overhang above rear overhang noted to be closed in with stucco with no drainage, suggested to repair accordingly. Remainder of the stucco overhangs have a perforated stucco casing that has been covered with paint. Suggested to open stucco casings and the gap behind the casing.

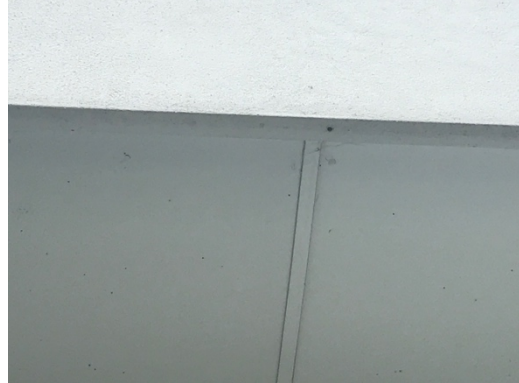
Stucco overhangs noted to terminate with a perforated casing. Many holes along the casing, however, have been covered with paint/ stucco materials. Suggested to re-open

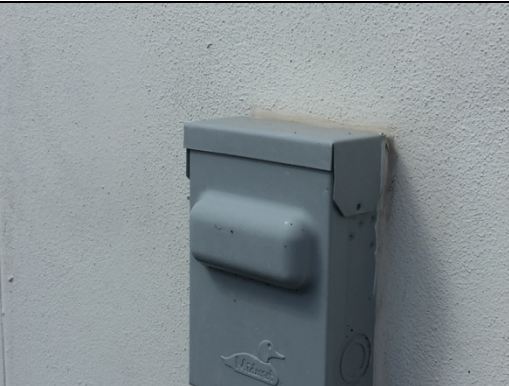
All penetrations through the stucco are lacking a quality, low modulus sealant, needed for **long lasting** protection against moisture intrusion

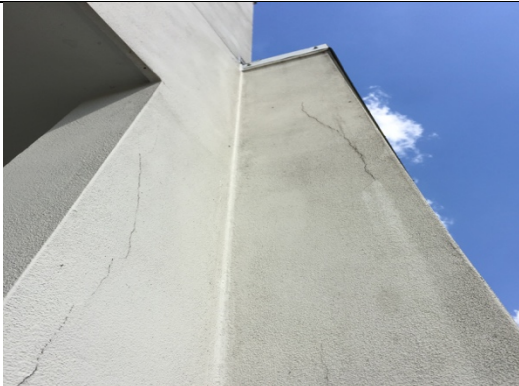
Hairline cracking noted in several locations. Suggested to seal/paint cracks throughout. Any thicker cracks should be grinded out and re-textured.

- Suggested to seal all hairline cracks throughout home. Exact reasoning for cracks not determined at time of inspection. Suggested to seal/paint cracks throughout. Any thicker cracks should be grinded out and re-textured. Paint is suggested at the 8-10-year mark as well, to alleviate all staining and cracks. Any cracks that are thicker, should be grinded out and re-textured

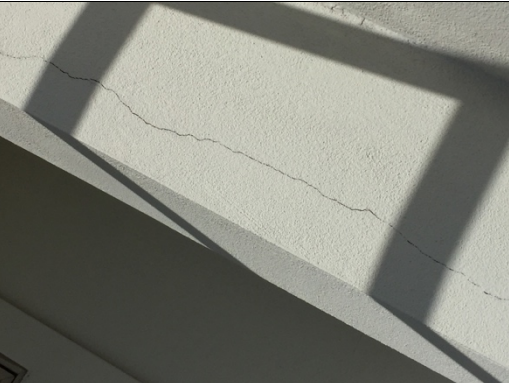
Hairline cracking noted in several locations. Suggested to seal/paint cracks throughout. Any thicker cracks should be grinded out and re-textured.

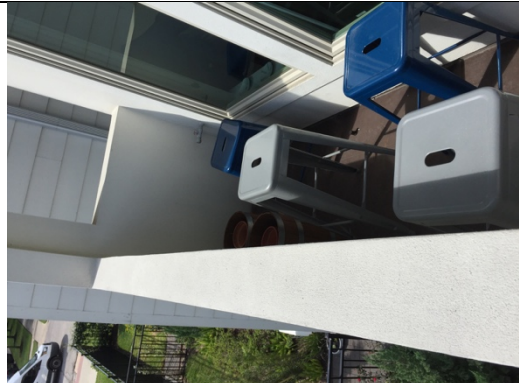
Front balcony walls terminate with a proper clearance from balcony flooring. Unable to determine weep screed presence at time of inspection

- Cap Flashing- Suggested to add a cap flashing to the front balcony walls.
